CALSPAN ON-SITE AMBULANCE CRASH INVESTIGATION

SCI CASE NO.: CA11026

VEHICLE: 2001 FORD F350 / MCCOY MILLER TYPE I AMBULANCE

CRASH DATE: OCTOBER 2011

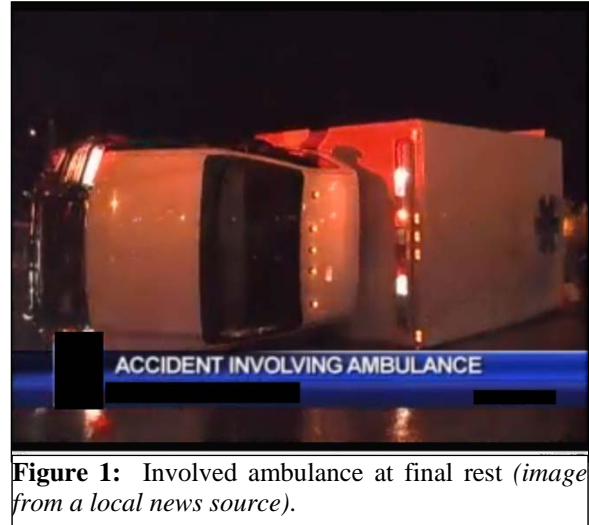
Figure 1: Involved ambulance at final rest (*image from a local news source*).

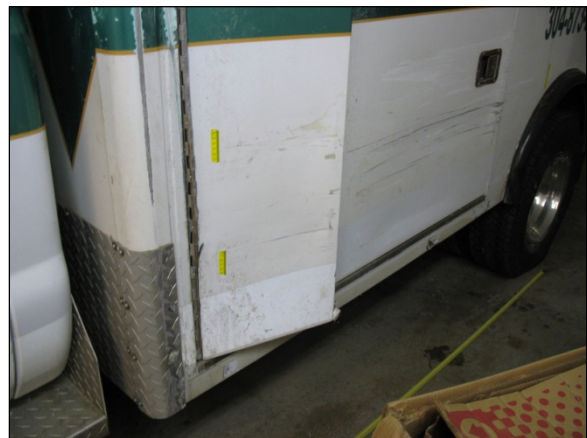
Damage to the exterior of the ambulance from the multiple event crash was limited to the left plane and consisted of abrasions and minor deformation. Direct contact from the Event 1 impact began 18 cm (7 in) aft of the leading edge of the patient compartment module on the left plane and extended 168 cm (66.2 in) rearward to 25 cm (9.8 in) forward of the left rear axle (**Figure 8**). The induced damage length shared the same measurements. Damage to the left plane from the first event impact consisted of slight lateral crush to the body/structure of the patient compartment module, with longitudinal sideswiping abrasions. The doors of the two forward exterior compartments of the ambulance, which were located within the damage pattern, were jammed shut by the lateral deformation.

Figure 8: Event 1 impact damage on the left plane of the McCoy Miller patient compartment module.

It should be noted that the forward most compartment's door was forced open post-crash by the ambulance agency's fleet manager for retrieval of the large on-board oxygen cylinder, and could not be closed due to deformation. A residual crush profile was measured on the left plane with a combined direct and induced damage length of 168 cm (66.2 in). Centered within the damage pattern at a height of 80 cm (31.5 in) above ground level, the profile consisted of the following measurements: C1–C2 = 0 cm (0 in), C3–C4 = 1 cm (0.5 in), and C5–C6 = 0 cm (0 in). Maximum crush was 1 cm (0.5 in). The Collision Deformation Classification (CDC) assigned to the ambulance, based on the SAE J224 MAR80 Recommended Practice definitions for a pickup truck of the same chassis type, was 10LBMS1.

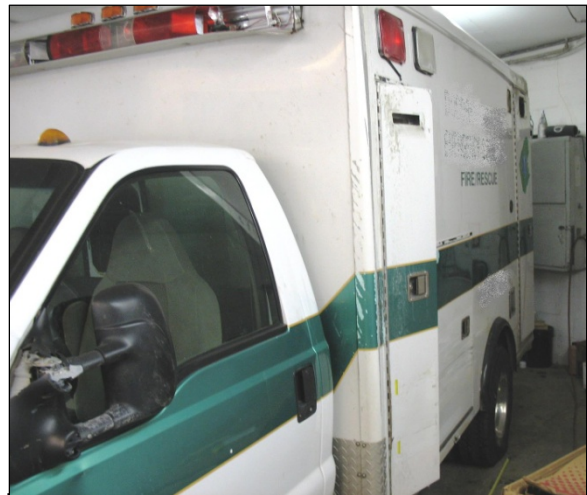
Exterior damage associated with the Event 3 rollover extended across the entire left plane. The left front fender was buckled and deformed right laterally with surface abrasions. The left side mirror was deformed right laterally at its pillar-mount, and the mirror glazing was out of place. On the exterior of the patient compartment module, there were heavy abrasions to the forward corner aspect and left roof side rail. The left aspect of the large emergency lights' colored lens, located on the forward plane of the module above the cab, was disintegrated. At the upper rear corner aspect of the patient compartment's left plane was an area of distinct direct contact

Figure 9: Rollover damage to the left plane of the ambulance.

damage. This area measured 72 cm (28.3 in) vertically and extended forward 76 cm (30 in) along the roof side rail from the upper rear corner. Maximum crush measured 3 cm (1.2 in) within this damage pattern on the roof side rail. An area of deformation at the upper rear corner of the patient compartment module was attributed to contact with the median curb on the overpass during the rollover sequence. The CDC assigned to the ambulance for the Event 3 damage pattern, based on a pickup truck of the same chassis type, was 00LDAO1 (**Figure 9**).

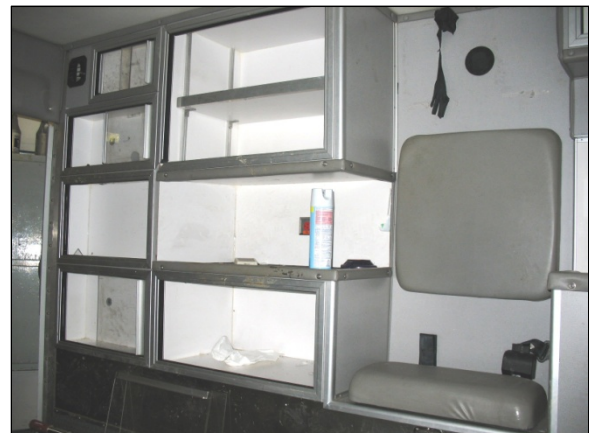
Interior damage to the patient compartment was sustained by the wall-mounted cabinetry on the left side. Seven of the fourteen sliding plexi-glass storage cabinet doors were fractured as a result of occupant contact and unsecured interior cargo contact during the crash, as well as egress of the occupants post-crash (**Figure 10**). During the rollover sequence, the unrestrained bench seat occupant initiated a forward trajectory with respect to his left-facing orientation, traveled over the stretcher, and contacted the storage cabinets immediately aft of the CPR seat. The force of this contact fractured the plexi-glass doors and loaded the plywood shelves, which resulted in the slight [< 1 cm (< 0.4 in)] separation of the angular joint of the shelf adjacent to the CPR seat. The remaining interior planes showed no evidence of damage or occupant contact.

Figure 10: Cabinetry damage to left side of patient compartment interior.

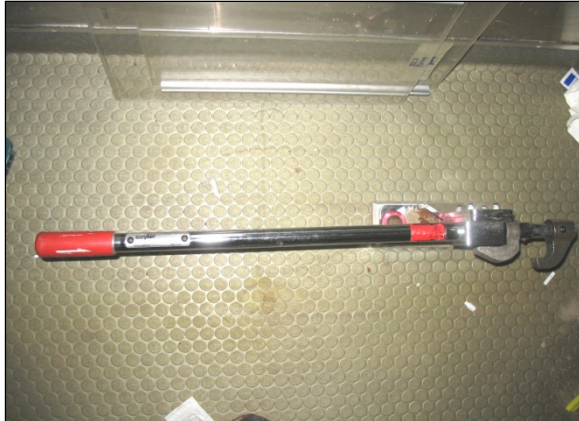
During the crash sequence, lateral and non-horizontal forces induced lateral and rotational movement to the stretcher (with respect to the patient compartment module’s floor). Due to the location of the locking-clamp mechanism at the left rear corner of the patient compartment module affixed to the right aspect of the stretcher (with respect to its orientation), the mass of the stretcher, aforementioned crash forces, and mass of the obese patient induced a negative moment of inertia about the longitudinal axis of the locking clamp. The vertical orientation of the clamp translated an equivalent perpendicular normal force through the anchor pin to the stretcher’s frame to restrict the lateral movement of the stretcher. Accordingly, the forces translated to the forward aspect (head area) of the stretcher, which rotated out of the antler bracket. This resulted in the right lateral rotation (with respect to the stretcher occupants’ orientation) toward the left wall cabinetry within the patient compartment.

As the ambulance completed the rollover and came to rest, the stretcher rotated slightly out of position. Consequently, the restrained obese patient came to rest lying on his right anterior side against the left wall cabinetry within the ambulance's interior and on the EMT's legs, with the stretcher in contact with his left posterior side. **Figure 12** depicts the locking-clamp mechanism within the Ford at the time of the SCI inspection; **Figure 13** depicts the forward antler bracket.

Figure 12: Locking-clamp mechanism of the Stryker Cot Fastener System at the time of the SCI inspection.

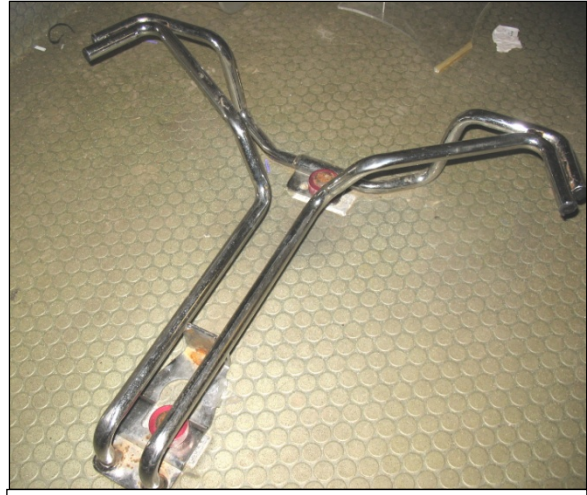
Figure 13: Forward antler bracket of the Stryker Cot Fastener System within the Ford.

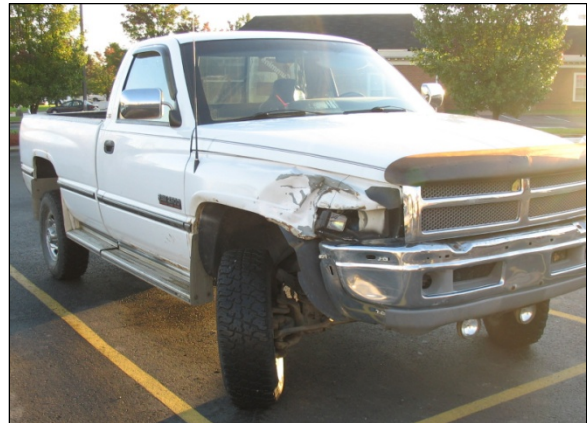
The Dodge did not sustain disabling damage as a result of the crash, and its driver retained possession of the vehicle post-crash and drove it from the scene. The SCI Investigator contacted the Dodge's driver via telephone, and cooperation was established to inspect the vehicle near his place of employment. Damage from the Event 1 impact was minor, limited to the front right corner of the Dodge (**Figure 15**). This included the rearward deformation of the bumper corner's right aspect and proximal surrounding components. The right front headlight assembly was disintegrated, and the right front fender was deformed. There was minor direct contact on the forward aspect of the right front tire/wheel, which consisted of a shallow laceration of the outer layer of the tire's sidewall and the minor indentation of the leading edge of the wheel rim.

Figure 15: Right front oblique view of the Event 1 damage pattern to the Dodge.

Both the direct contact and induced damage to the frontal plane began 70 cm (27.5 in) right of center and extended 30 cm (11.8 in) to the right front bumper corner. A residual crush profile documented at mid-bumper level produced the following results: C1 - C5 = 0 cm (0 in), C6 = 19 cm (7.5 in). The CDC associated with this Event 1 damage pattern was 03FREE2.
